# COAL ASH IMPOUNDMENT SITE ASSESSMENT FINAL REPORT

**Dallman Power Station  
City of Springfield  
Springfield, Illinois**

**KLEINFELDER PROJECT NUMBER 112618-6**

**May 10, 2011**

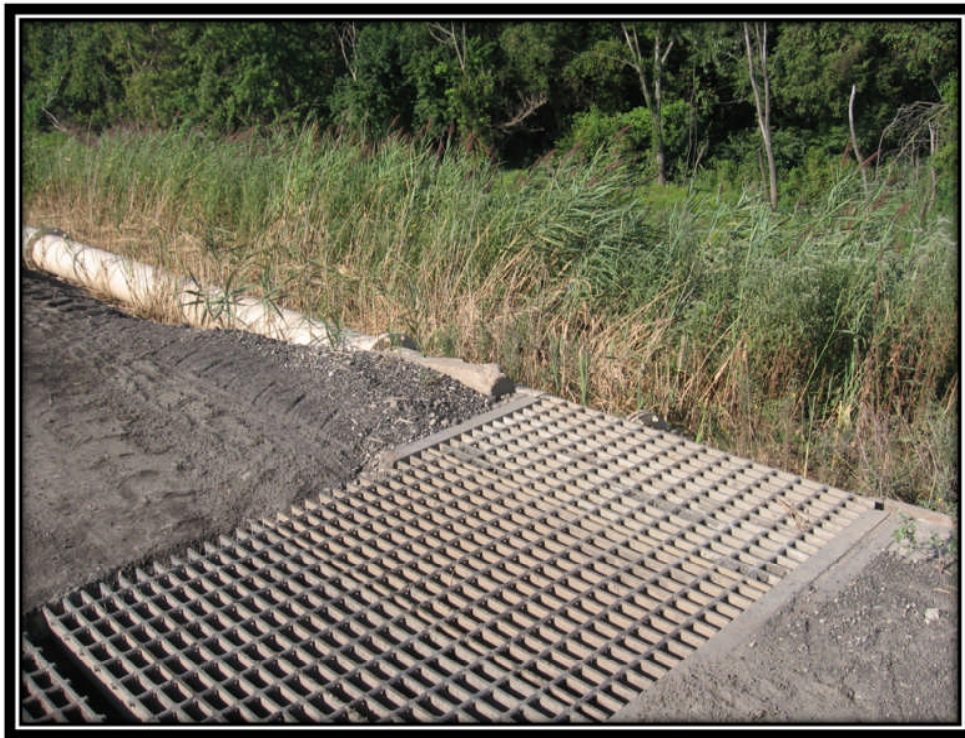
Overall, the downstream slope was in satisfactory condition. Photograph 9 shows the conditions of the downstream slope. Specific observations include:

Photo 9 – Grate on Crest Providing Roadway Access Over Sluice Pipe Inlet into Dallman Ash Pond

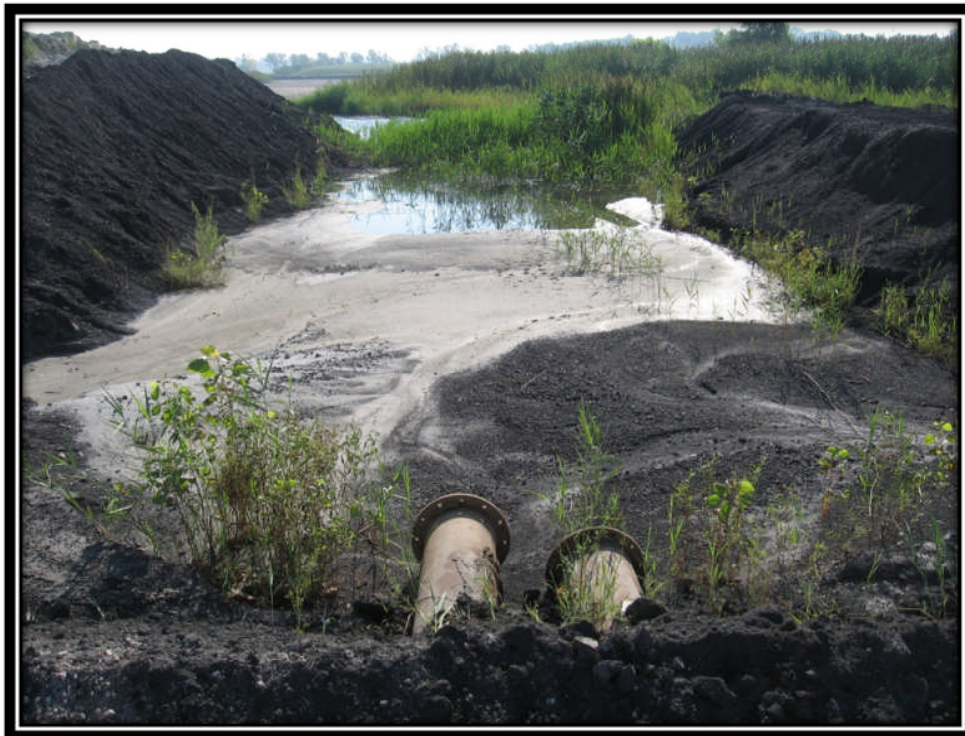
Photo 10 – Alternate Sluice Pipes (Not Active during Inspection, Note Cut in Embankment)

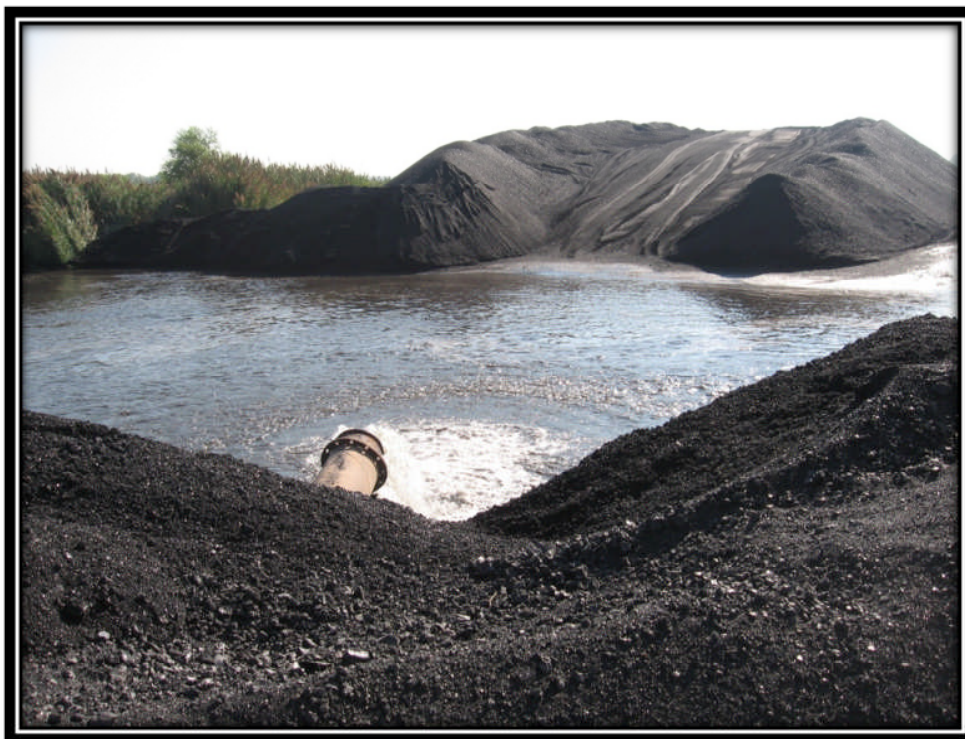
Photo 12 – Boiler Slag Sluice Pipe into Dallman Ash Pond (Note Backfilled Embankment)

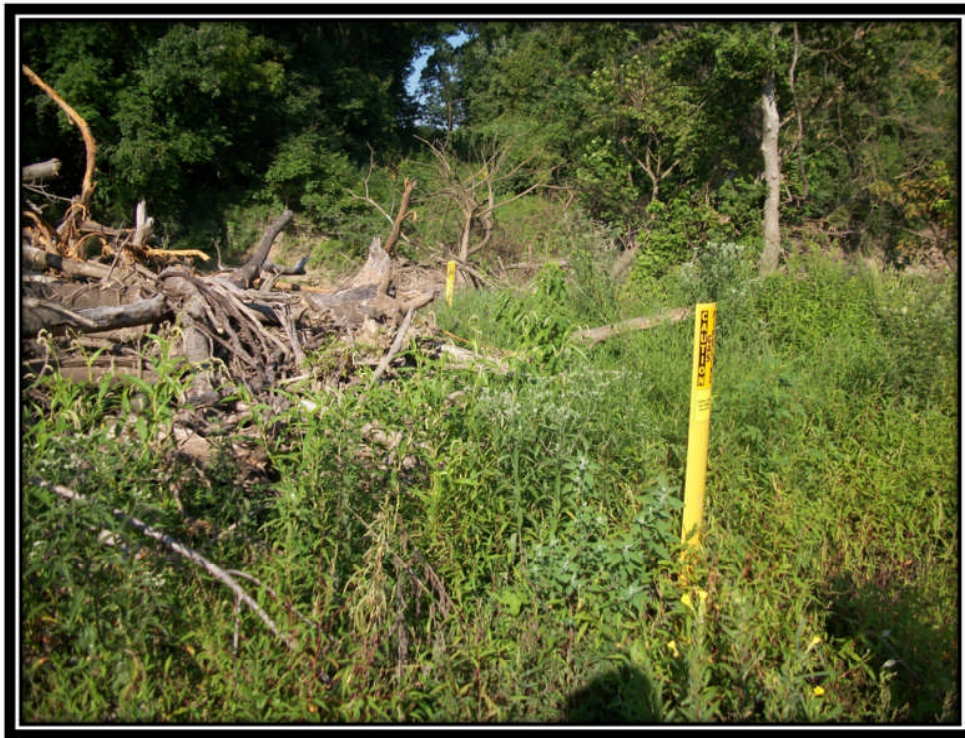
Photo 17 – Gas Pipeline Penetrating Embankment between Dallman Ash Pond & Clarification Pond

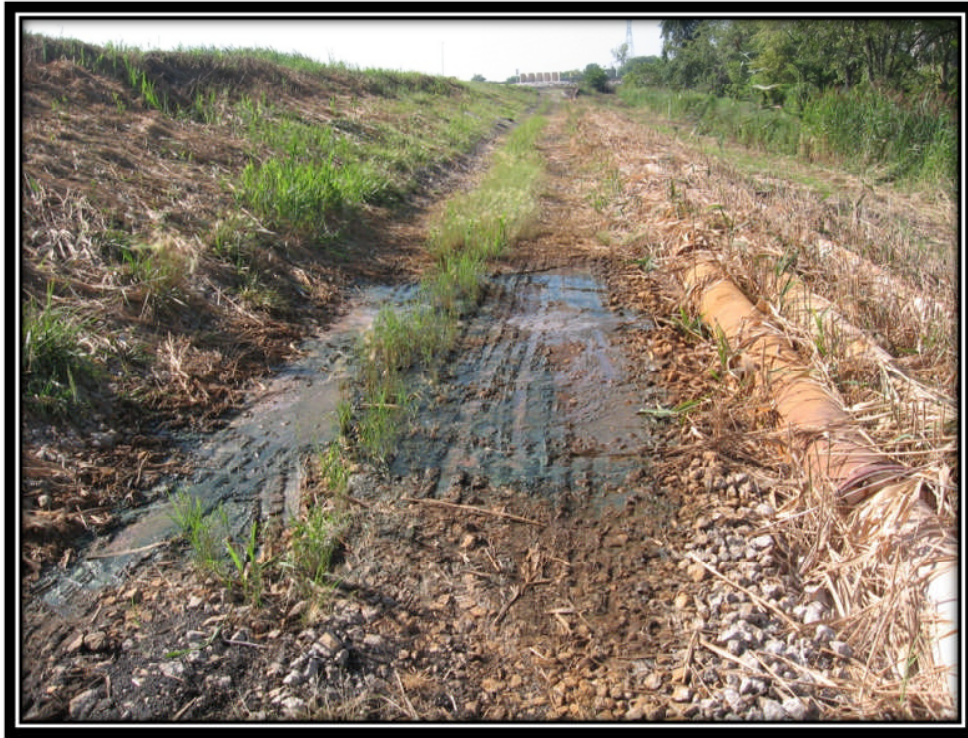
Overall, the downstream slope was in satisfactory condition. Photographs 25, 26, and 27 show the conditions of the downstream slope. Specific observations include:

- Uncontrolled seepage was noted on the west downstream slope near the juncture between the original top of embankment and the toe of the raised portion of the embankment. This area also serves as a vehicle access road.
- Portions of the downstream slopes were covered with thick vegetation.
- Sluice lines are located on the west downstream slope.

Photo 25 – Seepage Area Looking South

3. **Establish seepage and ground water monitoring program by 10/1/2011.** As discussed in Section 3.5, uncontrolled seepage water was observed on the west downstream slope of the Lakeside Ash pond. The presence of uncontrolled seepage water at the downstream embankment raises questions regarding the integrity and the stability of the embankment. Therefore, a detailed monitoring program should be established to quantify various important factors, including seepage quantities through the embankment, the amount of sediments carried by the seepage water, and the fluctuation of ground water levels.
